Contract #: 04-0120F4Cty: SF/ALA Rte: 80 PM: 13.2/13.9File #: 99.28**WELDING INSPECTION REPORT****Resident Engineer:**Siegenthaler, Peter**Address:** 333 Burma Road**City:** Oakland, CA 94607**Report No:** WIR-017425**Date Inspected:** 16-Oct-2010**Project Name:** SAS Superstructure**OSM Arrival Time:** 700**Prime Contractor:** American Bridge/Fluor Enterprises, a JV**OSM Departure Time:** 1900**Contractor:** Zhenhua Port Machinery Company, Ltd (ZPMC)**Location:** Shanghai, China**CWI Name:** Li Yang and Zhu Zhong Hai**CWI Present:** Yes No**Inspected CWI report:** Yes No N/A**Rod Oven in Use:** Yes No N/A**Electrode to specification:** Yes No N/A**Weld Procedures Followed:** Yes No N/A**Qualified Welders:** Yes No N/A**Verified Joint Fit-up:** Yes No N/A**Approved Drawings:** Yes No N/A**Approved WPS:** Yes No N/A**Delayed / Cancelled:** Yes No N/A**Bridge No:** 34-0006**Component:** OBG Trial Assembly**Summary of Items Observed:**

Orthotropic Box Girder (OBG) at Trial Assembly Areas

WELDING INSPECTION REPORT

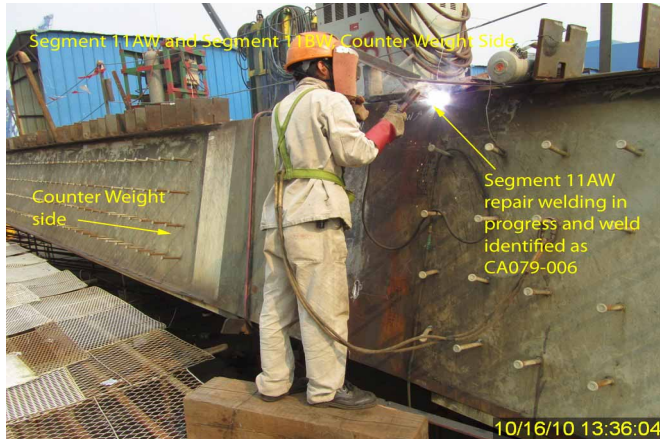
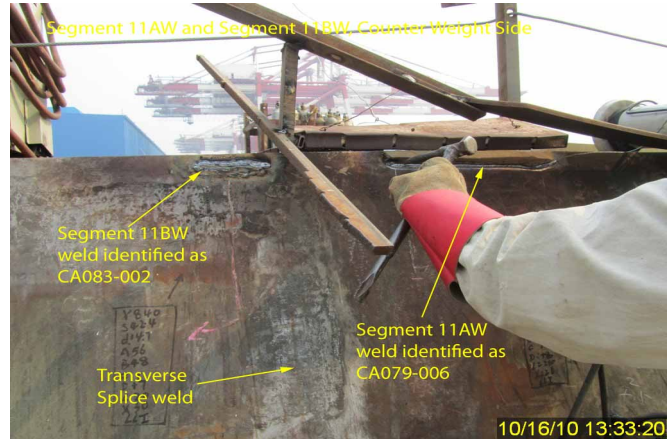
This QA Inspector observed the repair welding by Shielded Metal Arc Welding (SMAW) process on a Complete Joint Penetration (CJP) groove weld. The weld joint was designated as CA079-006. The welder identification was 046709 and observed welding in the 4G (Overhead) position using approved Welding Procedure Specification WPS-345-SMAW-4G(4F)-FCM-Repair-1. The piece mark was identified as Corner Assembly hold back weld at work point W2. ZPMC performed repair welding in accordance with B-WR-160008.

This QA Inspector observed the repair welding by Shielded Metal Arc Welding (SMAW) process on a Complete Joint Penetration (CJP) groove weld. The weld joint was designated as CA083-002. The welder identification was 046709 and observed welding in the 4G (Overhead) position using approved Welding Procedure Specification WPS-345-SMAW-4G(4F)-FCM-Repair-1. The piece mark was identified as Corner Assembly hold back weld at work point W2. ZPMC performed repair welding in accordance with B-WR-16008.

This QA Inspector observed the repair welding by Shielded Metal Arc Welding (SMAW) process on a Complete Joint Penetration (CJP) groove weld. The Weld joint was designated as OBW11B-004. The welder identification was 040611 and observed welding in the 3G (Vertical) position using approved Welding Procedure Specification WPS-345-SMAW-3G(3F)-FCM-Repair-1. The piece mark was identified as the Side Panel transverse splice on cross beam side. ZPMC performed repair welding in accordance with B-WR-15989.

This QA Inspector observed the repair welding by Shielded Metal Arc Welding (SMAW) process on a Complete Joint Penetration (CJP) groove weld. The Weld joint was designated as OBW11B-002. The welder identification was 040378 and observed welding in the 4G (Overhead) position using approved Welding Procedure Specification WPS-345-SMAW-4G(4F)-FCM-Repair-1. The piece mark was identified as the Side Panel transverse splice on counter weight side. ZPMC performed repair welding in accordance with B-WR-16012.

This QA Inspector observed the repair welding by Shielded Metal Arc Welding (SMAW) process on a Complete Joint Penetration (CJP) groove weld. The Weld joint was designated as OBW11B-001. The welder identification was 040378 and observed welding in the 4G (Overhead) position using approved Welding Procedure Specification WPS-345-SMAW-4G(4F)-FCM-Repair-1. The piece mark was identified as the Side Panel Corner Assembly transverse splice on counter weight side. ZPMC performed repair welding in accordance with B-WR-16012.
